As a member of the Hunter College community and the United States Army Corps of Engineers, I have been working with my colleagues to document, determine and repair the damages to the NY beaches and barrier islands. Our initial mission is to aid NY State and Suffolk County in designing breach closure procedures and cost estimates.

Hurricane Sandy battered the coastline for several tidal cycles producing severe flooding of coastal communities and erosion for many NY and NJ beaches. The prolonged storm surge and waves in excess of 25 ft breached the NY barrier island system in 3 locations (Figure 1). Two of the breaches, located within Suffolk County park lands will be closed immediately to prevent any unanticipated flooding of bayside communities. The breach within the Fire Island National Seashore will remain open and be monitored extensively to determine the effects of barrier island breaches on circulation and water quality in Great South Bay.

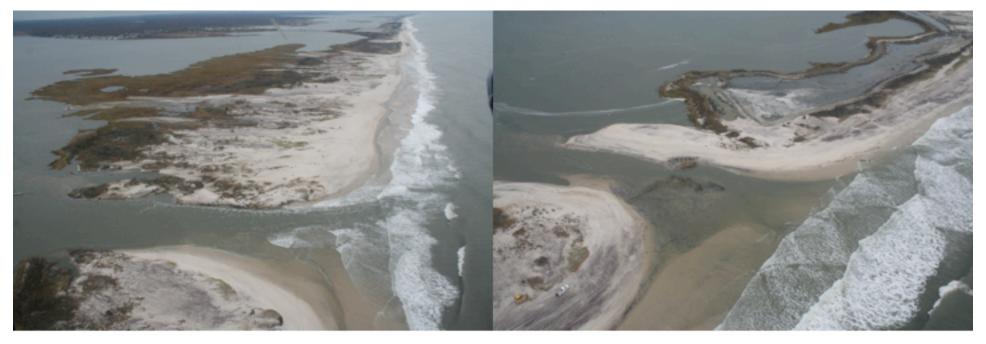
Breach 1: Wilderness Area, Fire Island National Seashore, 11-2-2012

Breach 2: Smiths Point County Park, Fire Island, 11-2-2012

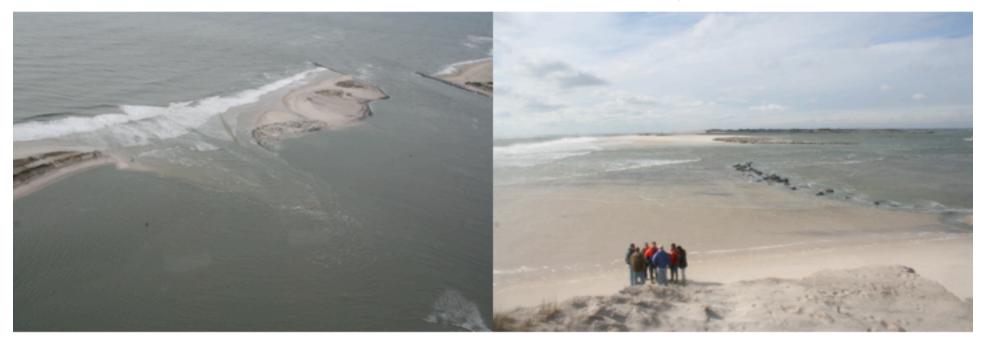
Breach 3: Cupsogue County Park, Dune Road, 11-2-2012

Breach 3: Cupsogue County Park, Ground Photo, 11-1-2012

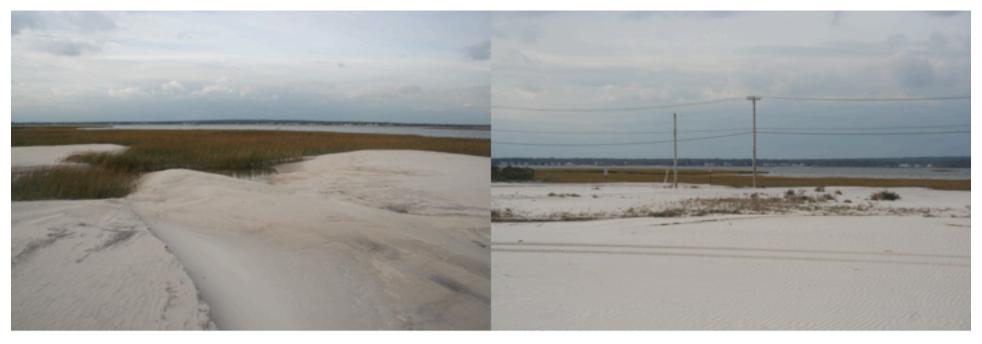
Overwash: Tiana Beach, Dune Road, Ground Photo 11-1-2012

The barrier islands also experienced overwashing, where dunes were wiped out and splayed across roads and wetlands in extensive fan deposits (Figure 2). In some of the more vulnerable washover regions, the elevations of the barrier islands remain a few feet above sea level. Without a protective dune, these locations may be susceptible to breaching during the 2012-2013 winter storm season which has just begun.

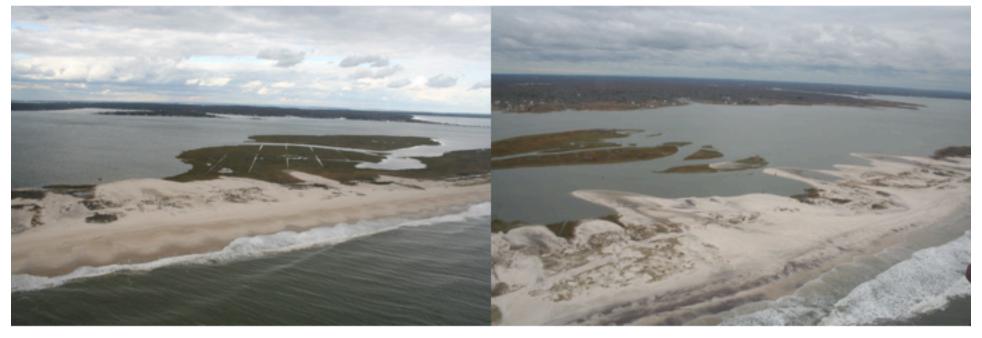
Overwash: Tiana Beach, Dune Road, 11-2-2012

Overwash: Smiths Point County Park, 11-2-2012
